COMMENTS AND OBSERVATIONS
ON THE DRILLING ACTIVITIES PERFORMED BY
EPA's TAT CONTRACTOR
AND SUBCONTRACTED DRILLER
DURING THE PERIOD OF
JUNE 23 THROUGH JUNE 27, 1992

PIONEER TECHNICAL SERVICES, INC.
P. O. BOX 3445
BUTTE, MONTANA 59702

JULY 13, 1992

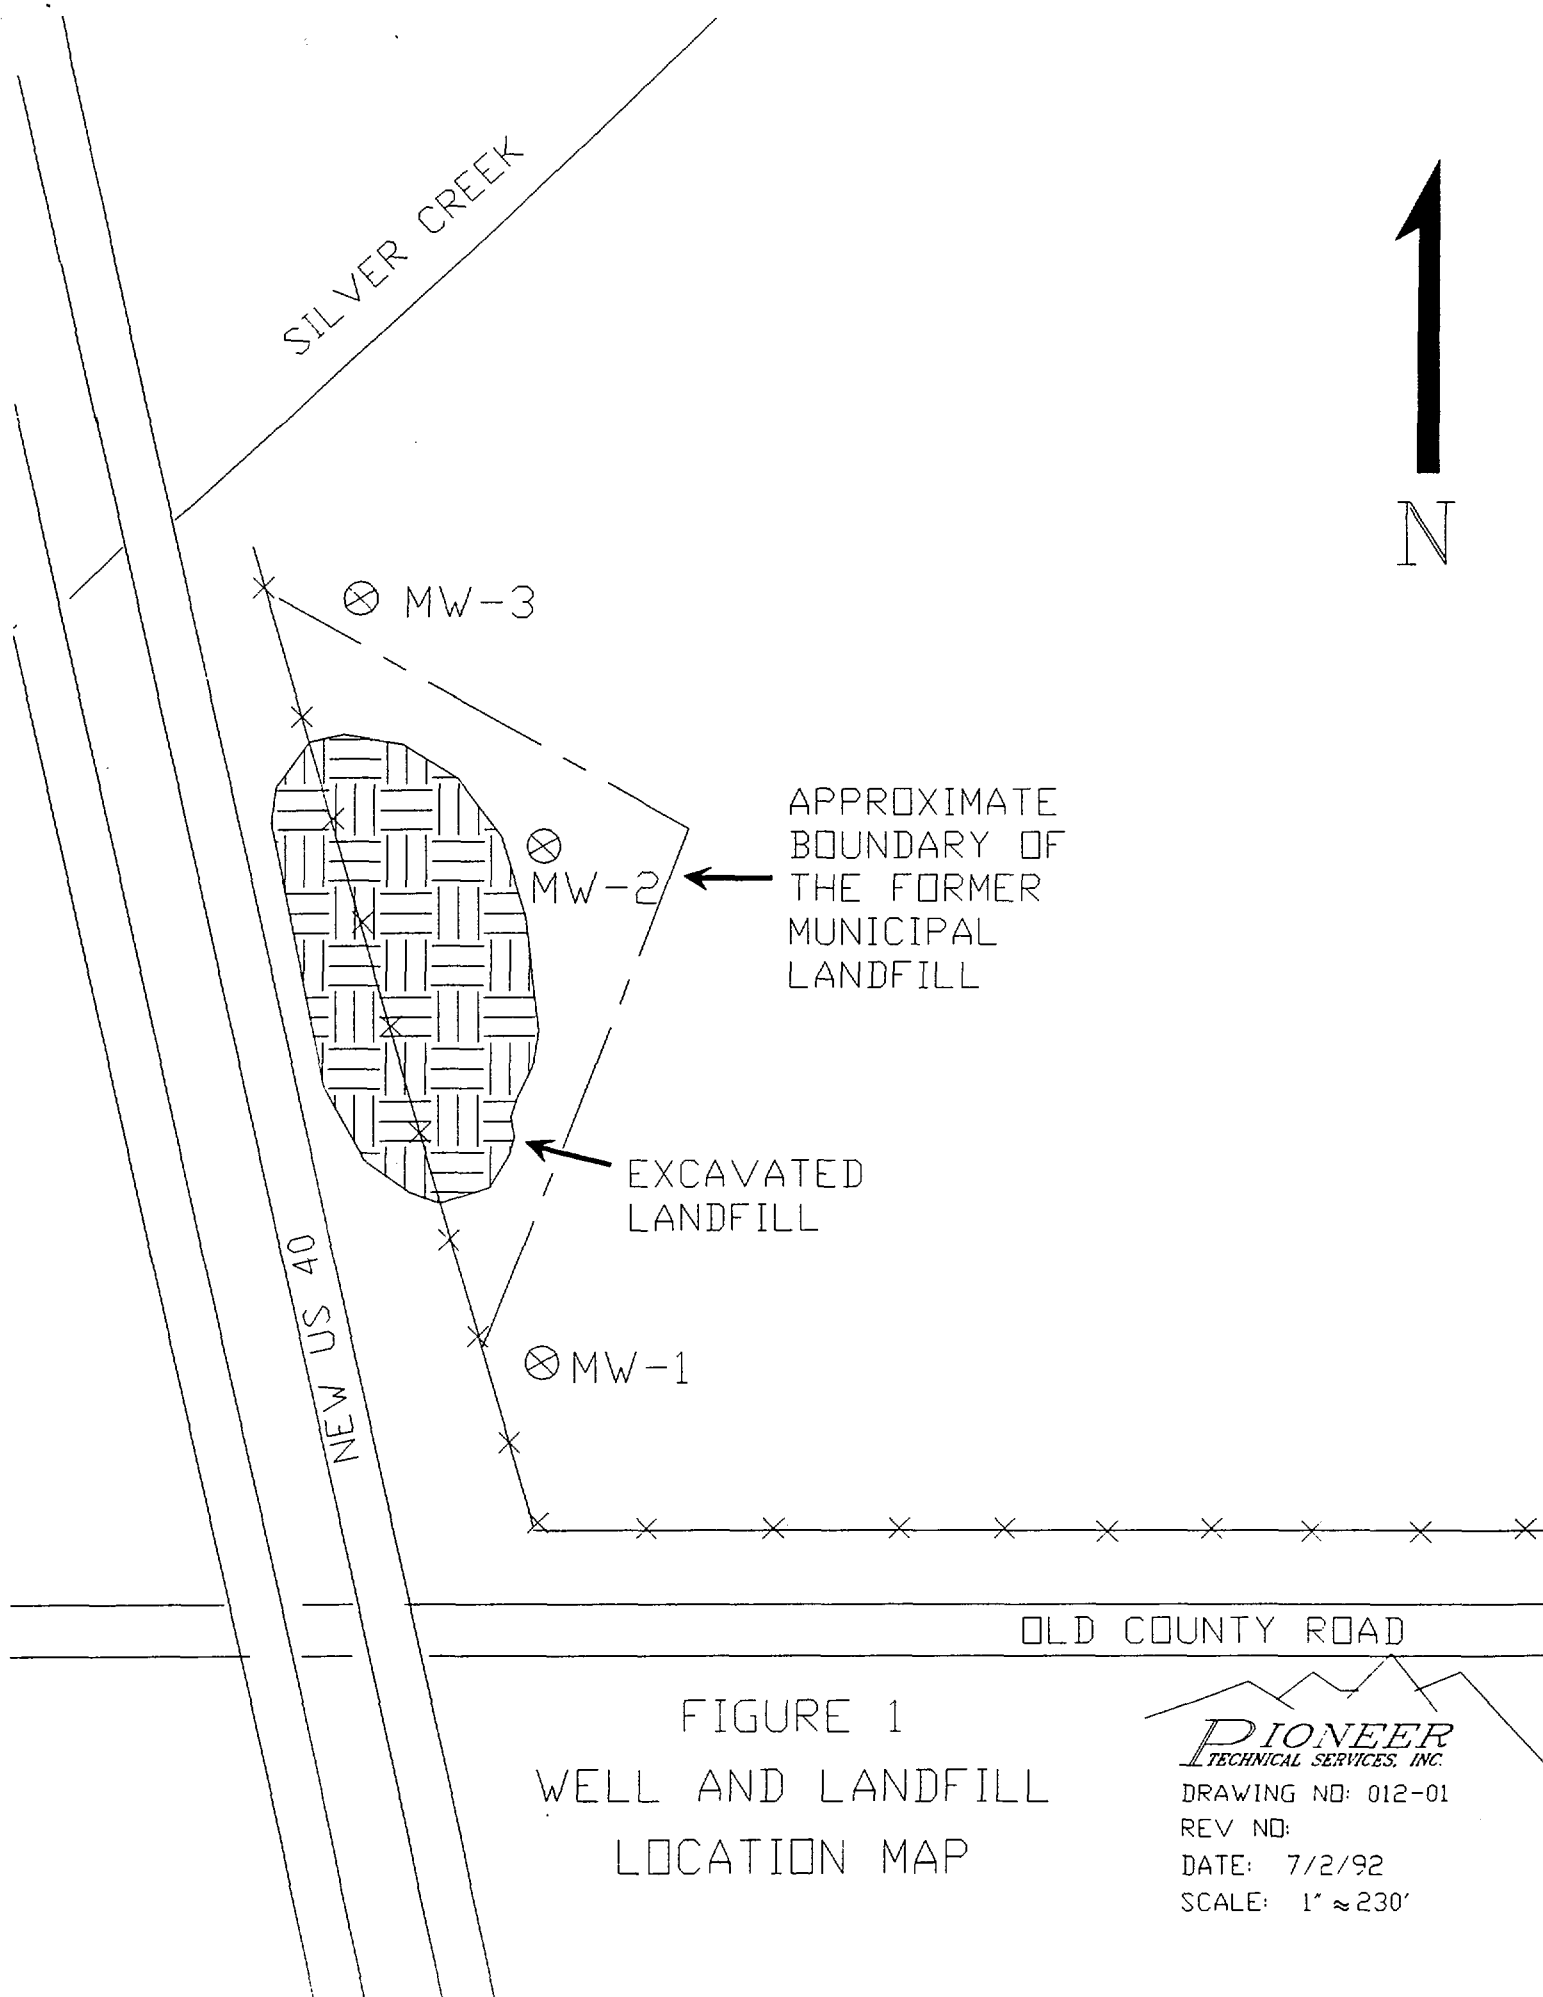
The most blatant violation of EPA guidance in the drilling of these monitoring wells was the placement of well MW-2 within the boundary of the historic landfill (see Figure 1). USEPA direction is clear - drilling directly through municipal landfills is to be avoided in order to protect underlying groundwater, and for obvious safety considerations; rather, drilling is to be conducted off of the actual landfill and downgradient from it. Prior to drilling, the TAT was advised by the property owner (UPCM) that the location selected for MW-2 was within the former landfill boundary. For whatever reasons, the TAT declined to relocate the well 100 feet to the north, out of the former landfill. After drilling five to ten feet, drill cuttings and split-spoon sample cores showed that the borehole was obviously within the landfill.

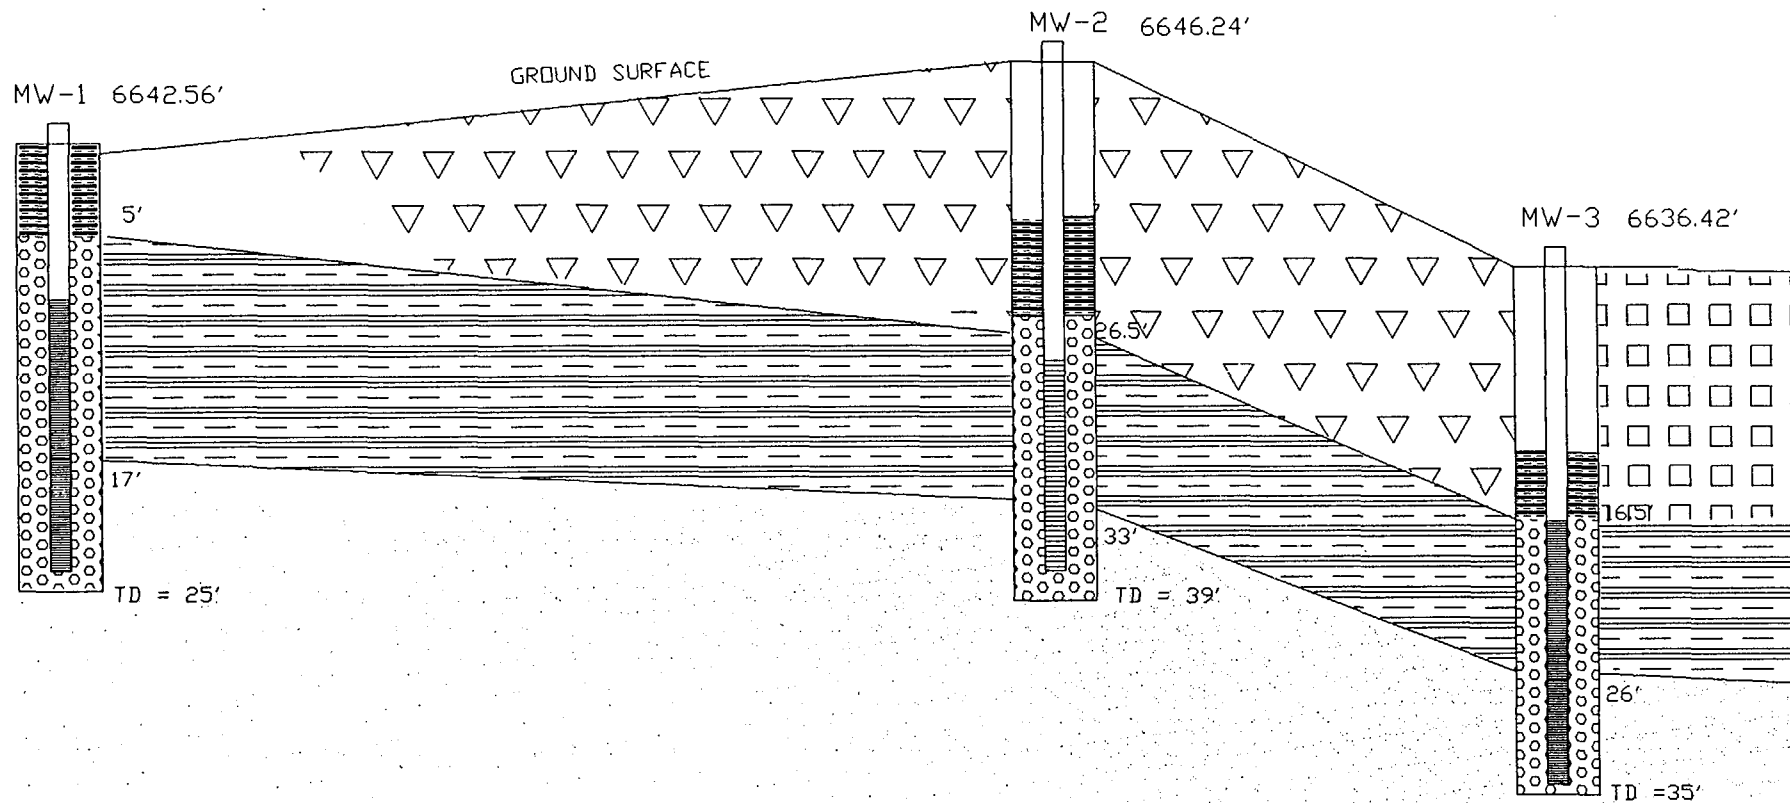
FIGURE 2
GEOLOGIC CROSS SECTION
AND LANDFILL MONITORING WELLS

At this point, serious errors in judgment and perhaps criminal negligence, caused the completion of well MW-2 to be entirely inappropriate, if not illegal. First, 10 feet of screen were placed in the well, bringing the screened section up to 27.5 ft bgs, very close to the top of the aquitard unit. Then, the filter pack was brought up to 26 ft bgs, above the aquitard. The bentonite seal placed on top of the sand was intended to plug the aquitard; however, due to careless geologic logging, it completely missed the aquitard and provides no such seal. The formerly continuous barrier between the landfill materials and groundwater has been breached by the drilling and not repaired during well construction. Water level measurements on subsequent days show clearly that the underlying water is under pressure and has risen up the borehole to exactly 26.5 ft bgs, the top of the aquitard. The underlying groundwater is now flowing up the well under pressure, out through the filter pack along the top of the clay aquitard and into the base of the formerly dry landfill. When this water discharges from the base of the landfill, either as springs or to Silver Creek, it will be contaminated by whatever is in the landfill.

- secondly, careful geologic logging would have shown the aquitard unit to be between 26.5 and 33 feet bgs, and hence, no need to screen above 33 ft bgs; and,
- finally, the placement of screen and sand up to the base of the aquitard (33-38 ft bgs) and bentonite within the aquitard (26-33 ft bgs) could have maintained the integrity of the natural barrier between the landfill materials and the underlying groundwater system.

The third well, MW-3, was moved further north at the urging of UPCM. During drilling, construction debris was encountered, but no municipal landfill wastes. This well encountered the same hydrogeology and was similarly misconstructed; however, the results are not as critical. The same aquitard (reddish-brown clay) was encountered in MW-3 at 16.5 ft through 26 ft bgs and water was again encountered beneath it. Instead of completing the well with the screened section at 26 to 34 ft bgs, TAT decided to place 15 feet of screen in this well, 5 feet into the aquitard. Filter pack was again placed in the borehole up to the top of the aquitard (16.5 ft bgs), and the bentonite seal above that, again missing the aquitard and not sealing the borehole. The result of this is again, the upward migration of formerly confined groundwater into the construction debris and eventually out of the filled area to surface water.

In any event, the serious nature of the well construction disaster described above is at least unprofessional and at worst illegal. I recommend that all of these wells be properly abandoned as soon as possible. It is especially critical that MW-2 be plugged so that it does not continue to flood the landfill.
